## Outbreak, Surveillance and Investigation Reports

### Ferry Boat Injuries and Deaths in Pattaya, November 2013; Its' Time for Thailand to Reclaim its Safe and Smile Traveling

On 3 Nov 2013, the Bureau of Epidemiology was notified of a ferry boat accident in Pattaya, Chon Buri Province. At least six deaths and 16 severe injuries were reported. The investigation team conducted a descriptive study to describe potential risk factors associated with injury and death, and determine the effectiveness of interventions on injury prevention after the accident. All medical records related to injuries and deaths from four hospitals were reviewed and interviews were held with patients, crew, health volunteers, rescuers and local authorities. The team also observed ferry boat transportation services. Medical records of 37 hospitalized injuries, including seven deaths, were reviewed. Of these, 59% were males, with median age of 31.5 years. Major causes of injury were muscle strain (35%), aspiration pneumonia (19%) and submersion (14%). Five out of seven fatalities used a buoyancy aid, with one victim's buoyancy aid reported to be "riding up", which led to drowning. Overcapacity of the boat an

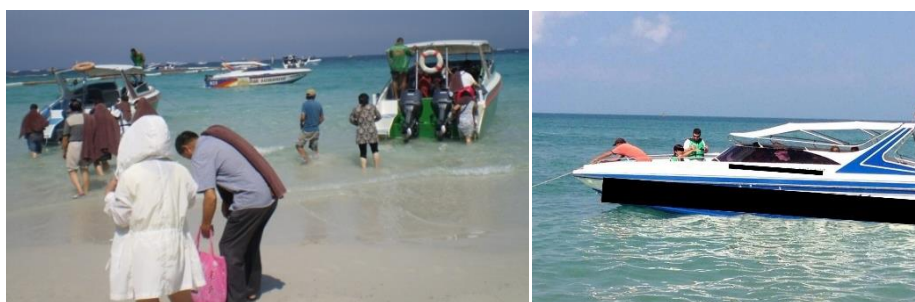
**Figure 1. Speed boats parking along the beach to board more passengers in Pattaya, Thailand, November 2013**

The average capacity of ferry boats varies from 150-200 passengers, according to size of boat and registered maximum capacity printed on the hull. Daily random inspection on maximum capacity of boats was conducted by marine officers at the port. However, boats could pick up more passengers along the beach during the trip (Figure 1).

Ferry and speed boats should carry passengers only from official ports so that local marine officers could check effectively for safety issues. The number of coast guards and patrol boats should be increased. Patrol boats should provide service daily and cover more areas around Koh Larn beaches. Above all, regular monitoring and policy enforcement will be an ongoing requirement to prevent future events.

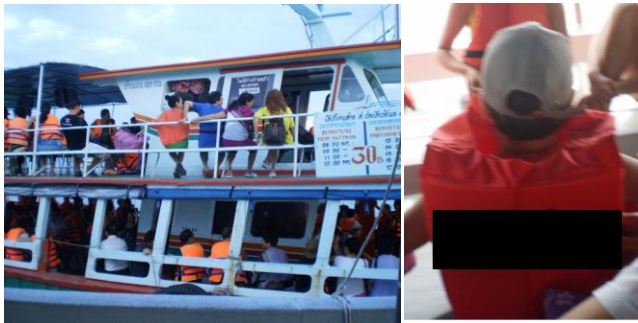
**Figure 2. Ferry boat transporting between Koh Larn to Pattaya, Thailand, November 2013, showing passengers without buoyancy aids and no size fit for children**

Speed boats are smaller and faster, with a capacity for 20-80 passengers. It takes approximately 20 minutes for each trip between Koh Larn and Pattaya. Ferry boats are larger with capacity of 150-200 passengers and take approximately 30-45 minutes to travel between Bali Hai Port in Pattaya to Na Baan or Ta Waen Port in Koh Larn. The cost of traveling by a ferry boat was cheaper than a speed boat, costing 30 Baht compared to 100-200 Baht for a speed boat.

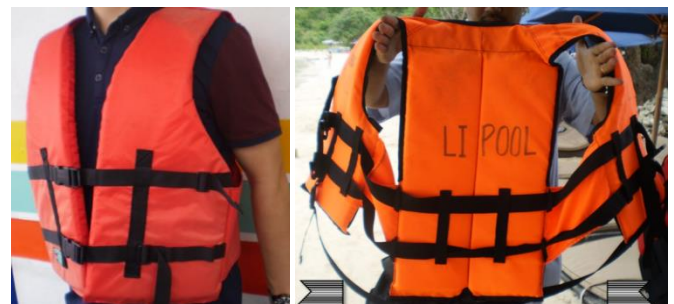
During our observation, although we saw a few buoyancy aids, no instructions were provided on board (Figure 4).

**Figure 4. Buoyancy aid on a ferry boat without leg strap (left) compared to the standard buoyancy aid used by the rescue team (right), Pattaya, Thailand, November 2013**

buoyancy aids for all passengers and crew. Additionally, from the team's observation on boat safety equipment from other companies covering the same route, we found that buoyancy aids were not appropriately designed. The design defect of buoyancy aids and inappropriate method of wearing them might have resulted in 'riding up', i.e., the buoyancy aid floating up over head and pushing the person's head under the water, resulting in drowning. According to the documents of the Marine Department, Ministry of Transport, there were specifications only for the life vest and appropriate specifications for buoyancy aids were still under revision.<sup>10-13</sup>

The Marine Department should also ensure that all boat companies provide all passengers with brochures on safety in multiple languages before the boat leaves the port. The brochures should include information on what to do in case of an emergency, including how to correctly put on buoyancy aid. The crew should also provide onboard demonstrations of putting the buoyancy aid on and make sure all passengers are wearing them. Compliance with these safety precautions should be randomly checked by local marine officers at least once a week. Boats found to be overcapacity or with passengers not wearing a buoyancy aid, should not be allowed to operate.
